EXETER RIVER STUDY 2008 ACTIVITIES

RIVERBANK SCOUR ANALYSIS AND DISCHARGE GATE DESIGN IMPACTS TO WATER QUALITY

for the
TOWN OF EXETER, NH
April, 2008

WRIGHT-PIERCE

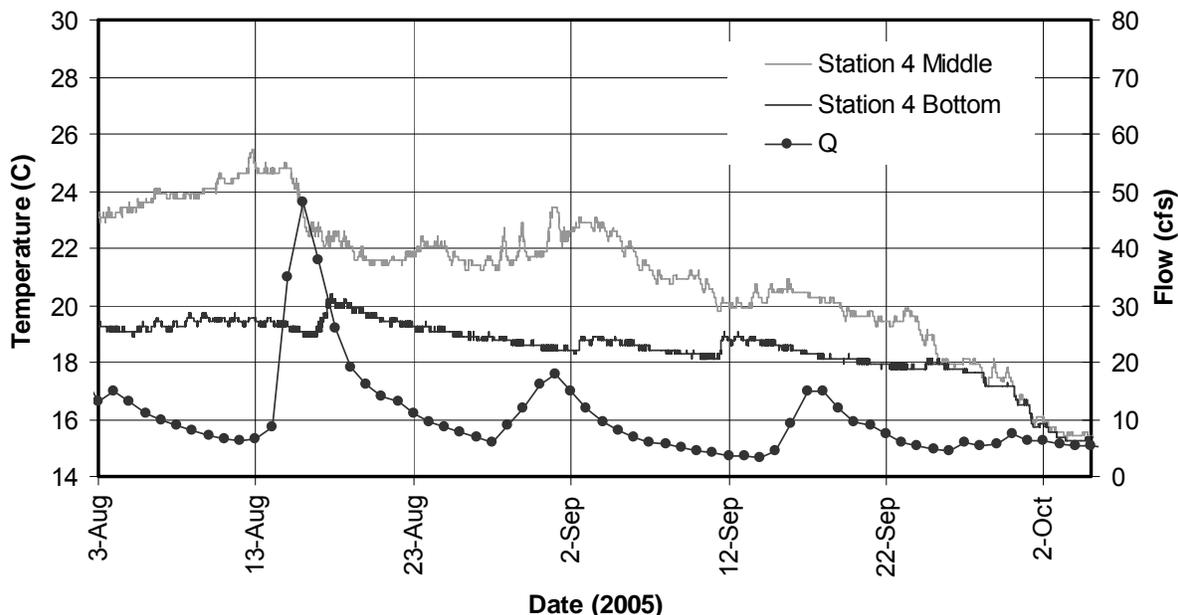
Figure 1: Water Temperature and Flow

of increased flow on the temperature difference. In particular, the higher flow of approximately 50 cfs on August 16, 2005, reduced the temperature gradient from approximately 5 to 2 degrees Celsius. Similar, though less pronounced reductions in thermal stratification are apparent during other periods of increased flow in the river.

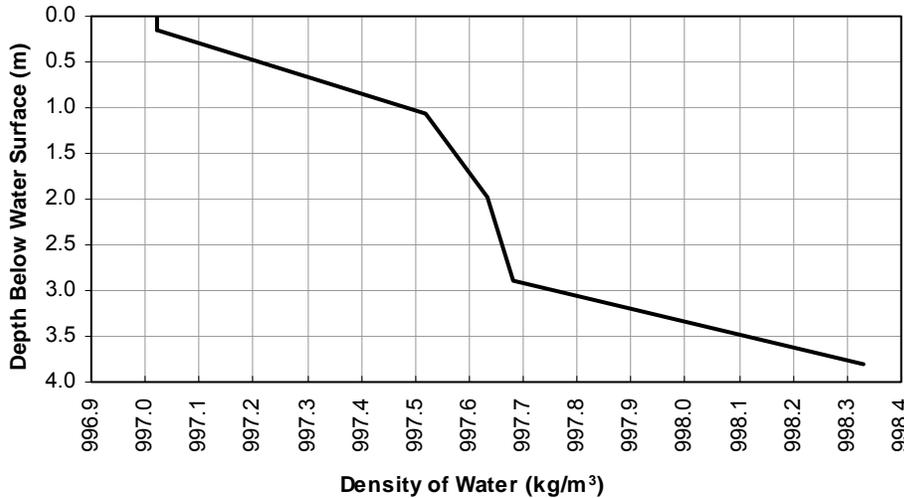
Figure 2: Water Density

purpose of withdrawal of water from the hypolimnion. While uniform vertical profile would provide for vertical stability of the water column, this does not appear to be a reasonable assumption.

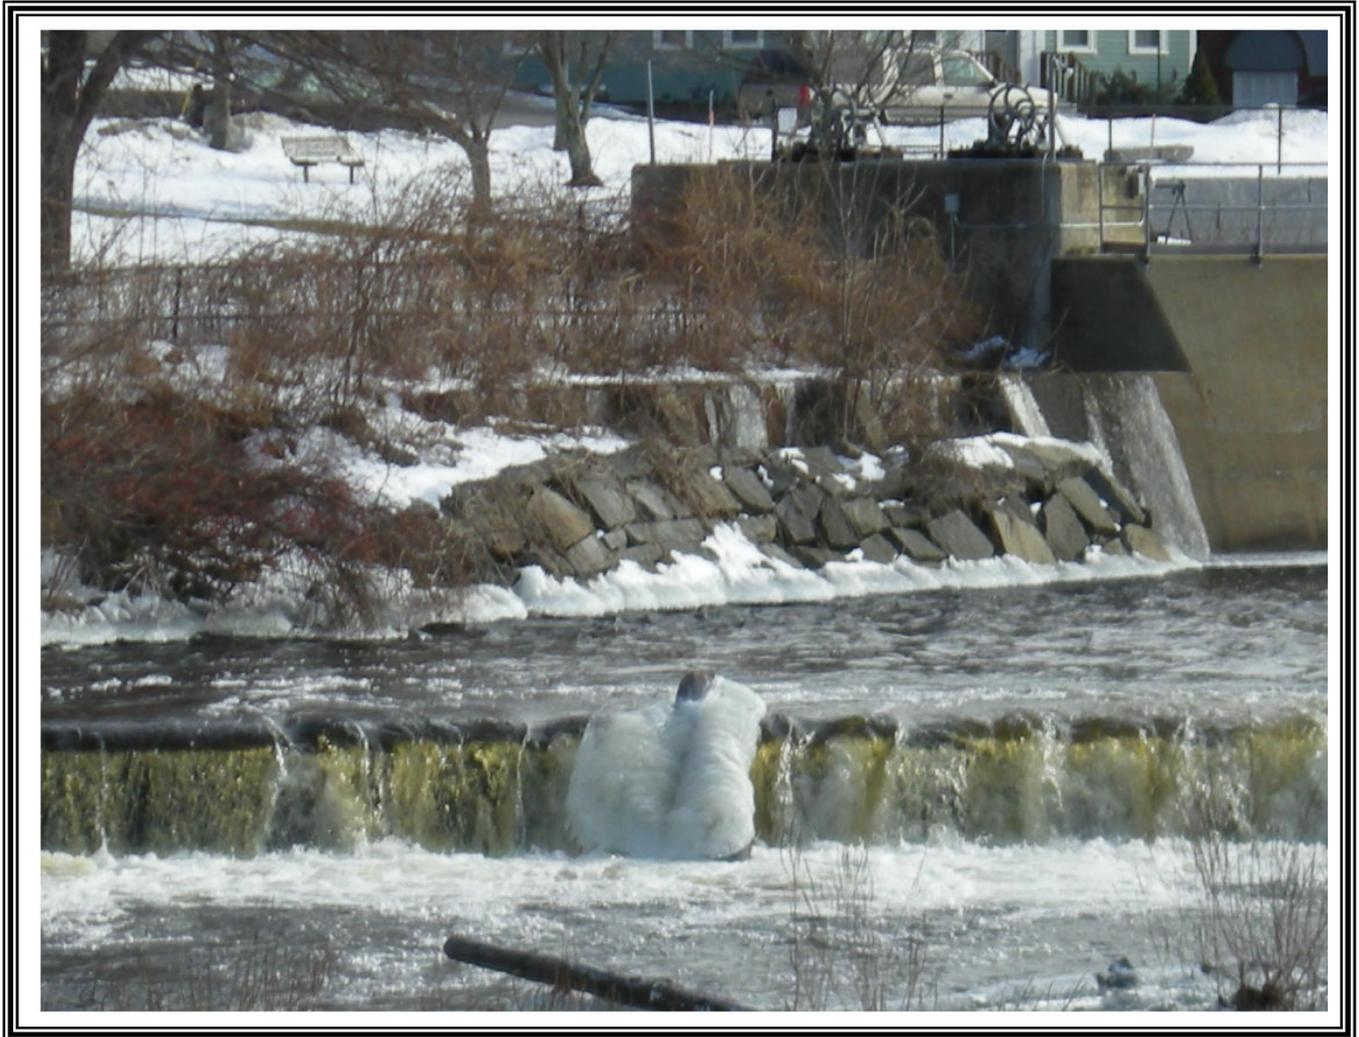
FIGURE 4
Flow over the fish weir on January 22, 2008

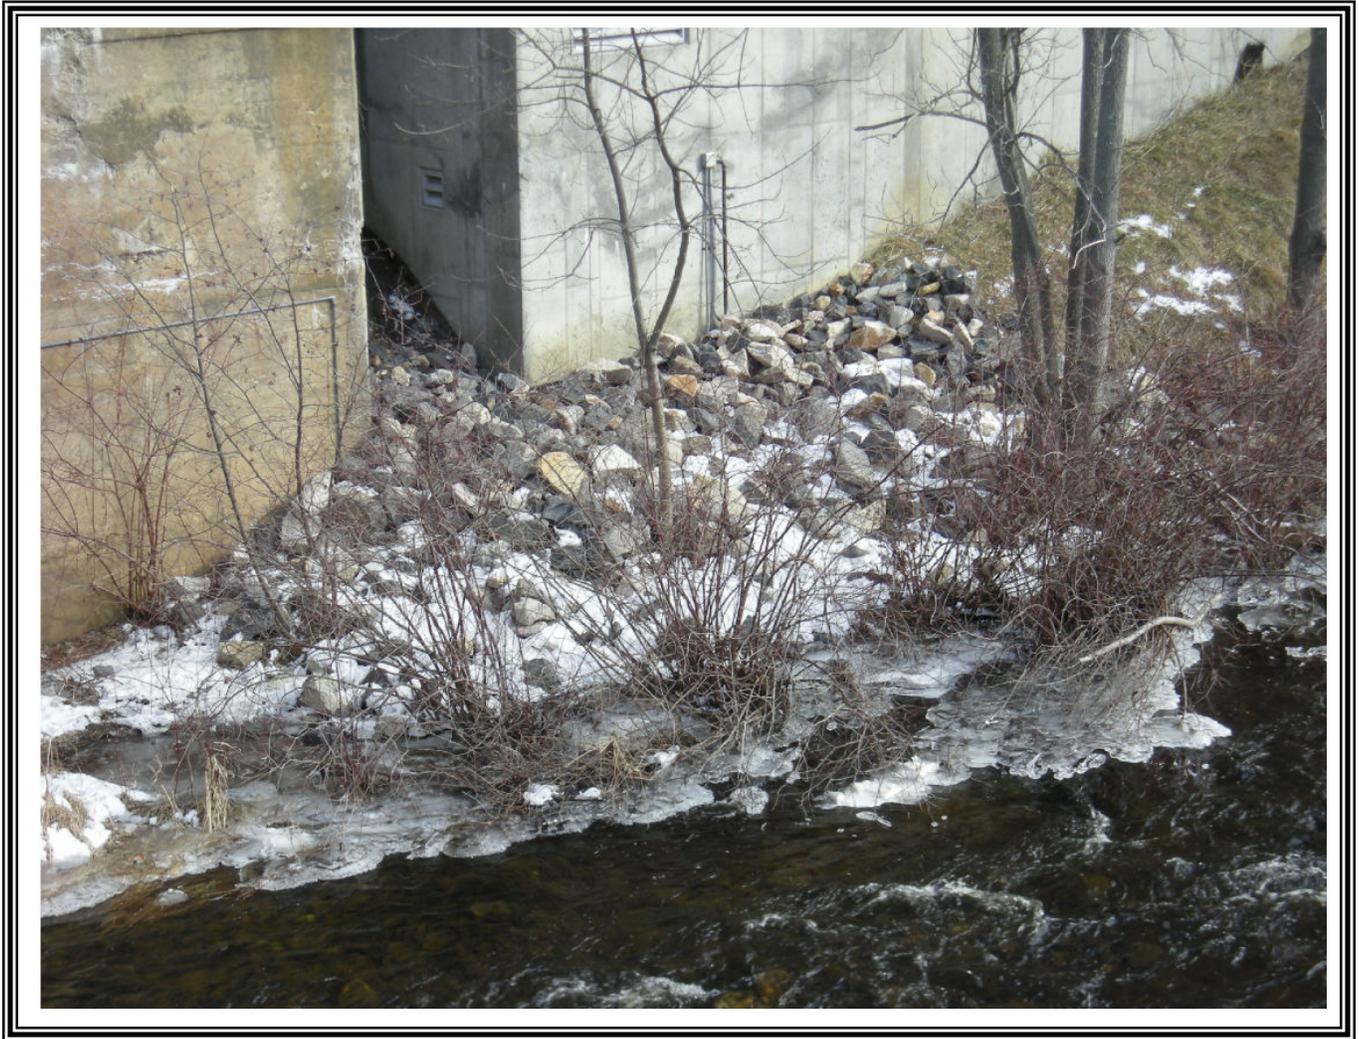
- A location of possible past erosion was found just upstream of String Bridge near the northwest corner of the library building corner (Figure 3, Area C). The embankment was covered with medium sized stone (6 to 10 inches in diameter), possibly placed after a significant high river flow event. Figure 5 is a photo taken of this area;

FIGURE 5
Stone near northwest corner of Library

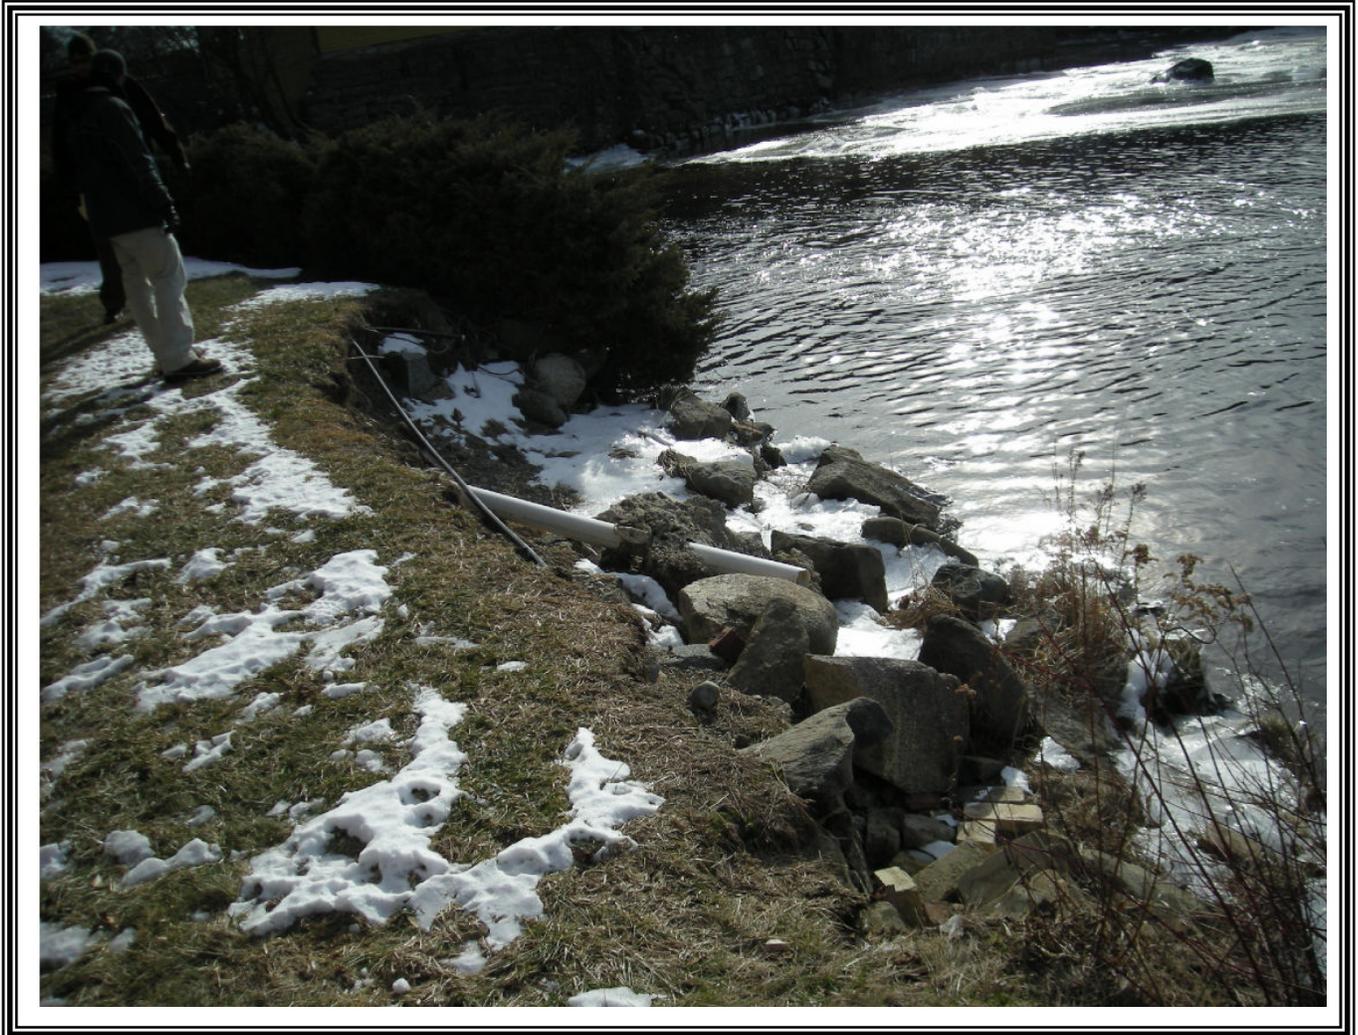
- Active embankment erosion was discovered on the Exeter Mill Apartments property just after the river bend downstream of String Bridge (Figure 3, Area D), possibly caused by eddying currents exiting into the Squamscott River. Figure 6 is a photo of the eroded area and Figure 7 is an aerial photo clearly showing the eddying currents downstream of the bend.

FIGURE 6
Erosion downstream of river bend caused by eddies

Field inspections noted an area of significant active bank erosion, likely due to eddies, at the confluence of the Exeter and Squamscott Rivers, near the Exeter Mill Apartments. It is recommended that this area be armored as well, using rip-rap of similar size.

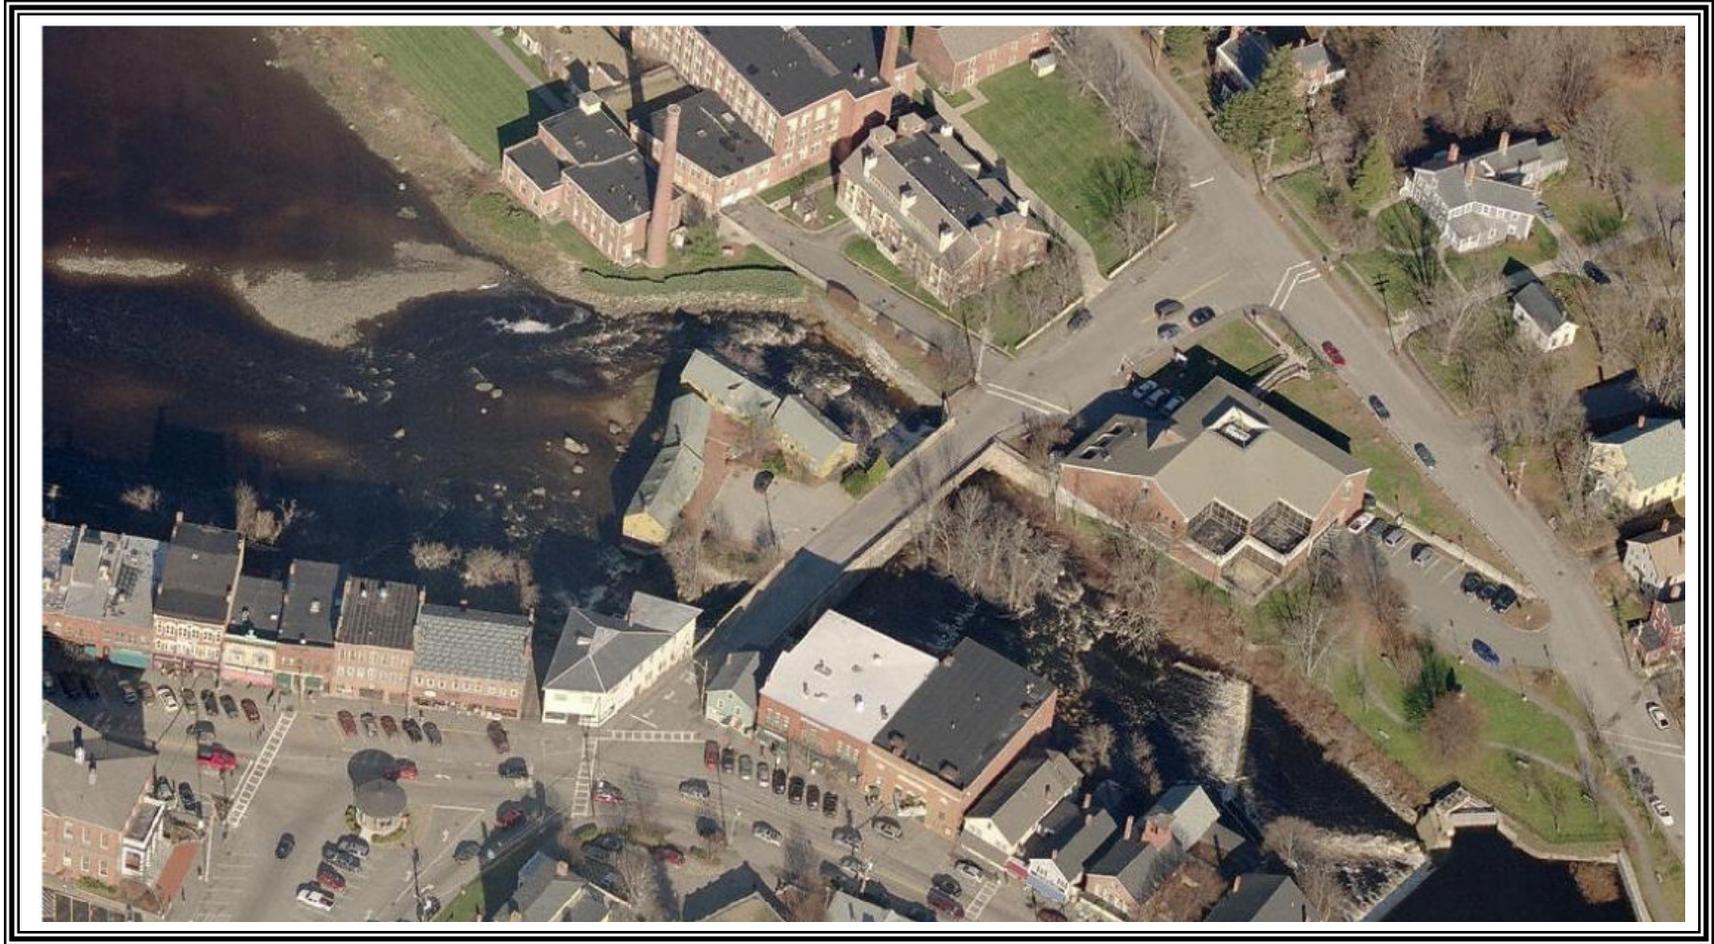
FIGURE 7
Aerial showing eddies near Exeter Mill
Apartments downstream of String Bridge

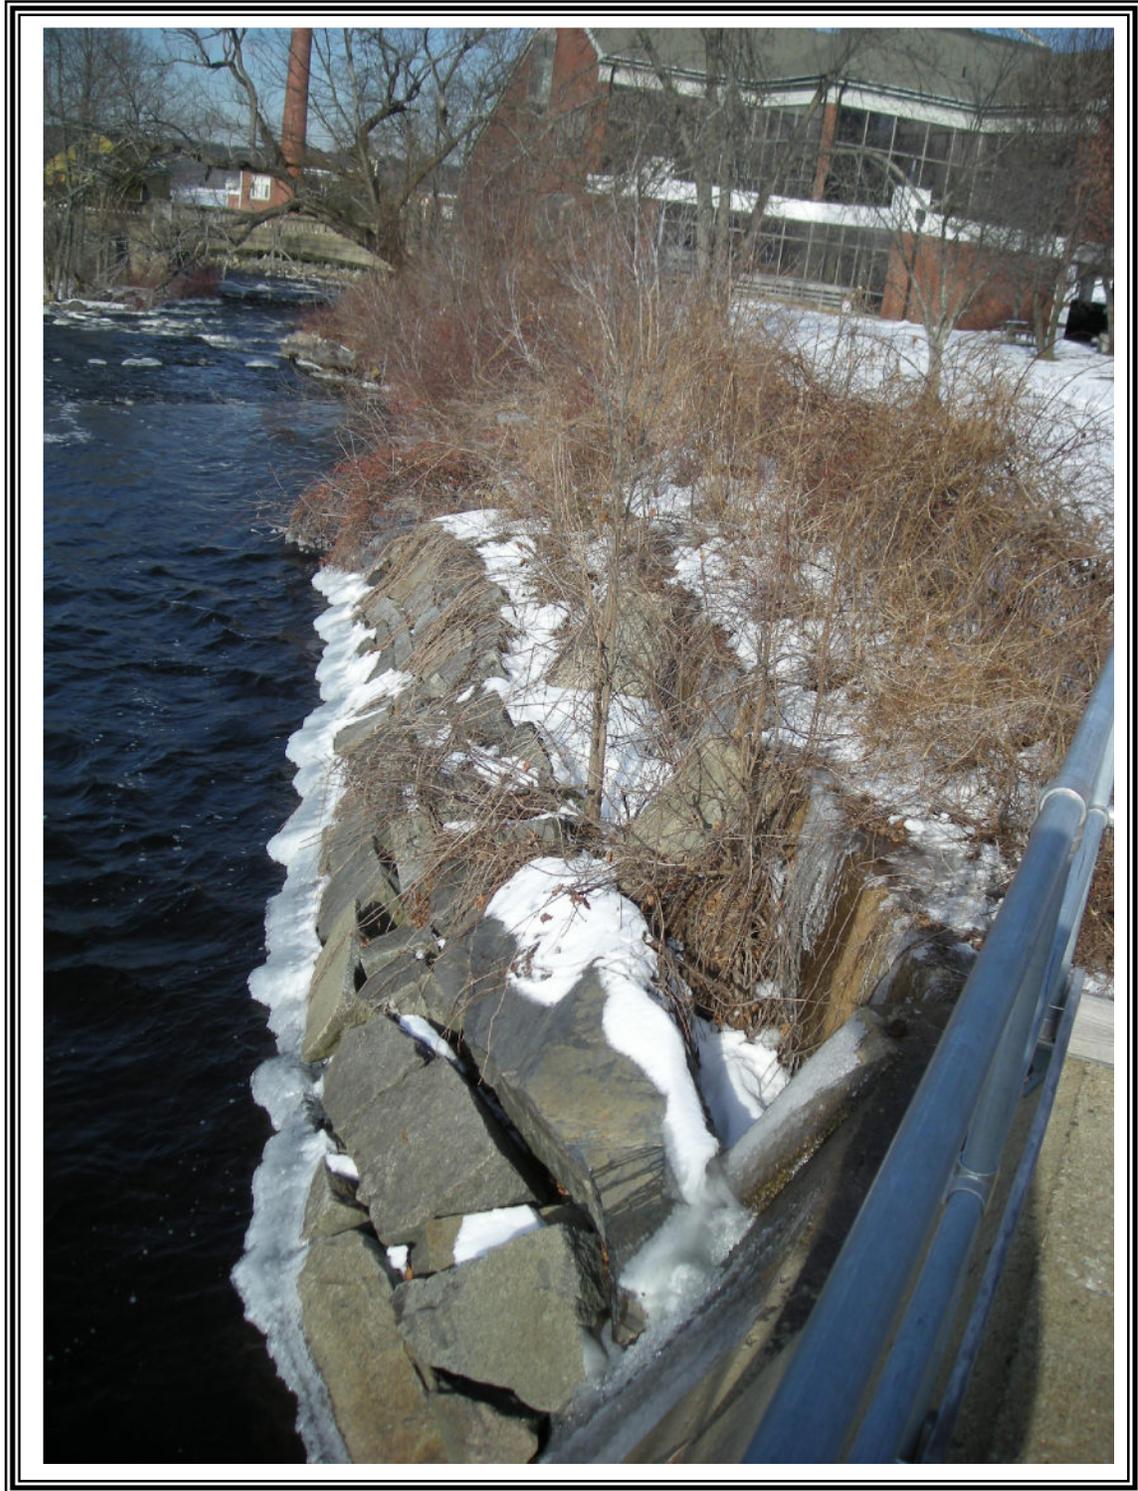
- Scour under String Bridge was not evident;
- Scour at the low flow gate was not evident;
- The right embankment just downstream of the Great Dam contains a rip-rap wall, with stones 18 to 24 inches in diameter that appear to be in good condition. Continuing downstream, between the fish weir and String Bridge, the right embankment contains some large rip-rap (18 to 24 inches in diameter) near the base of the embankment. Figures 8 and 9 show the existing armored embankments;

FIGURE 8
Embankment armoring immediately
downstream of the Great Dam

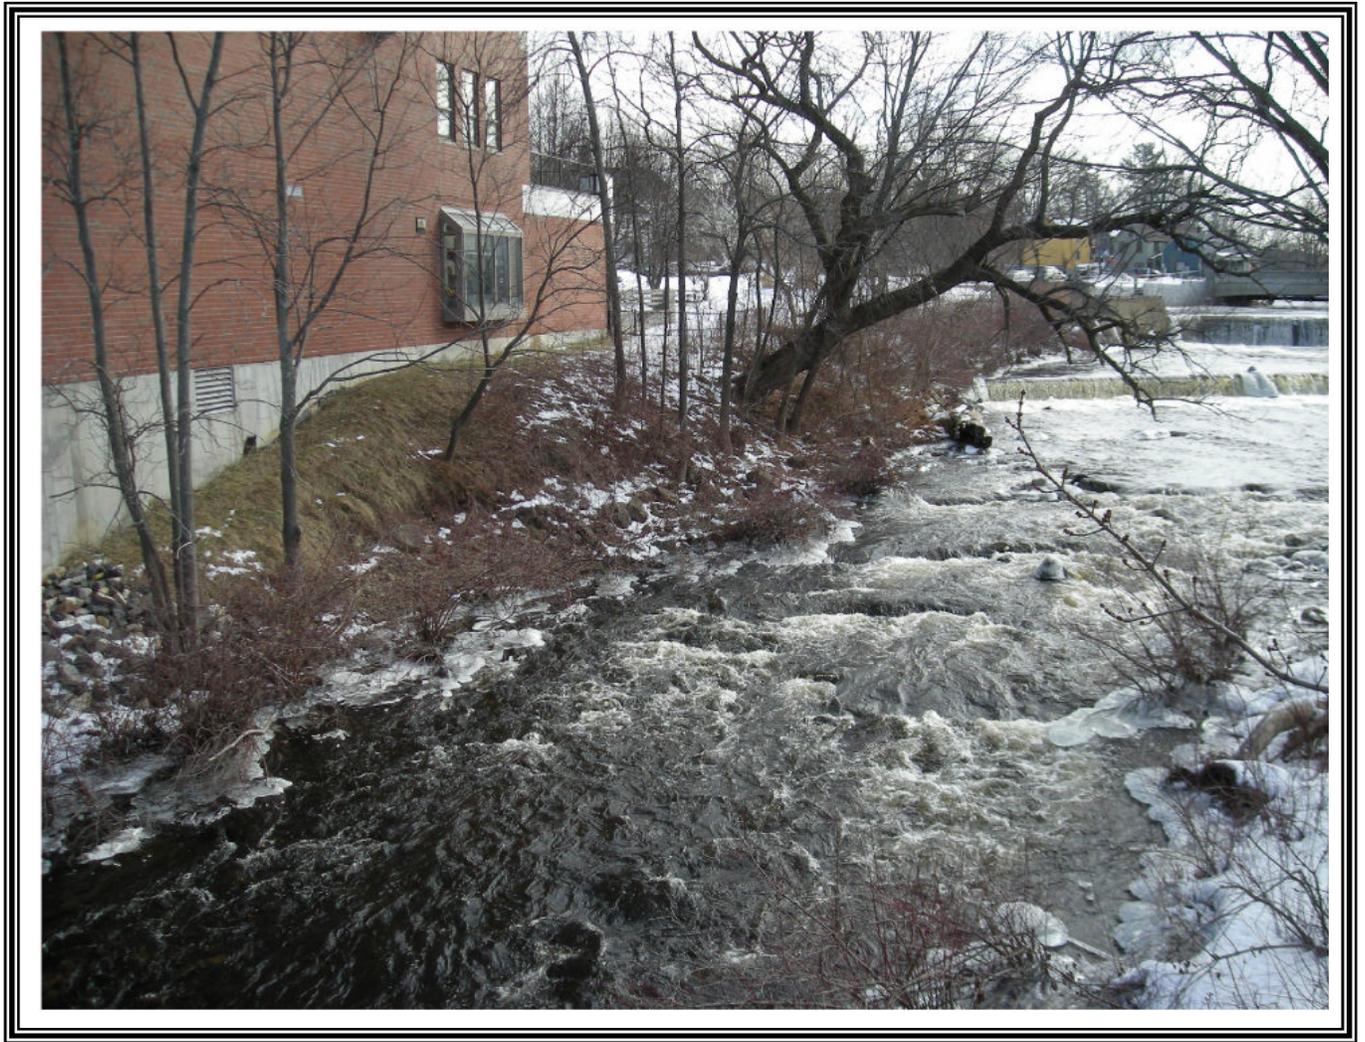
FIGURE 9
Embankment armoring between the Great
Dam and String Bridge

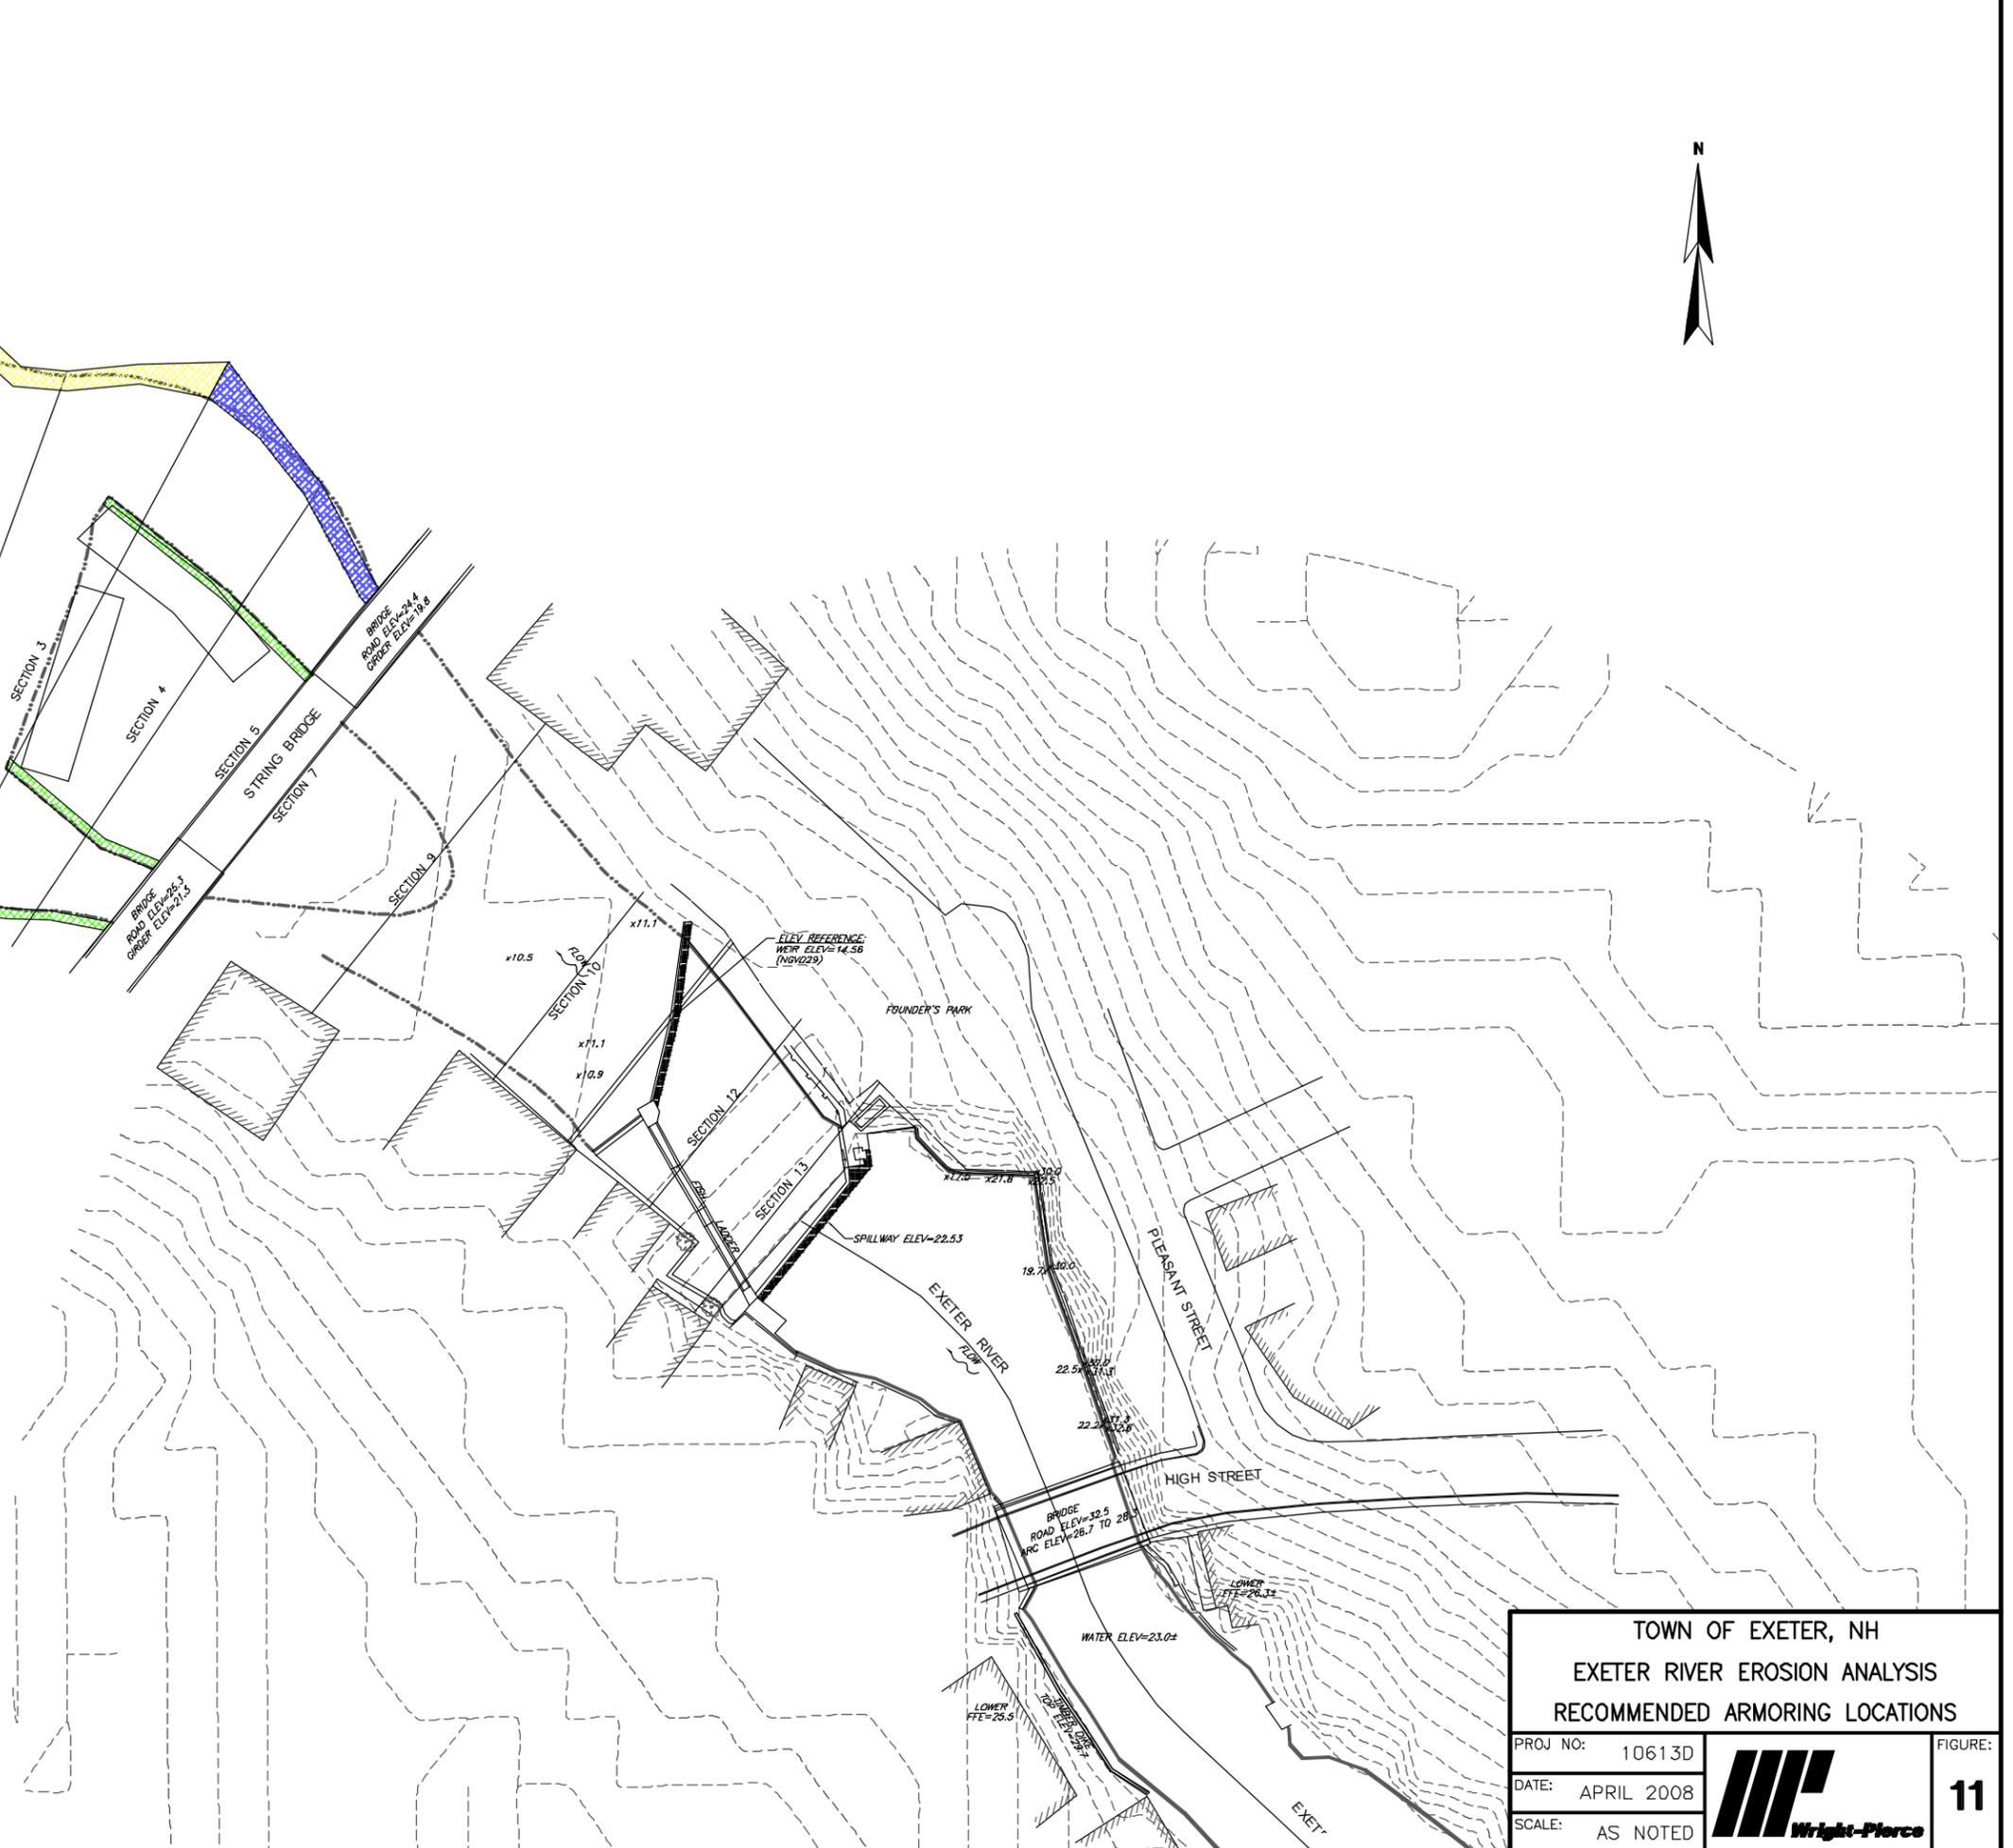
TOWN OF EXETER, NH			FIGURE: 11
EXETER RIVER EROSION ANALYSIS			
RECOMMENDED ARMORING LOCATIONS			
PROJ NO:	10613D		
DATE:	APRIL 2008		
SCALE:	AS NOTED

- ARMOR AT BASE OF RETAINING WALL
- ARMOR UP EMBANKMENT SLOPE
- MAINTAIN EXISTING ROCKWALL/LEDGE ARMORING

It is recommended that the armoring be placed at the base of the retaining wall just downstream of String Bridge, and along the embankment slope around the river bend, extending from just downstream of the retaining wall through the area of active bank erosion near the Exeter Mill apartments. It is also recommended that the existing rock wall/ledge armoring be maintained along the left embankment of the northern channel and along both embankments of the southern channel. Figure 11 shows the recommended locations for armoring and Figure 12 provides a detail for the typical placement of rip-rap along river banks.

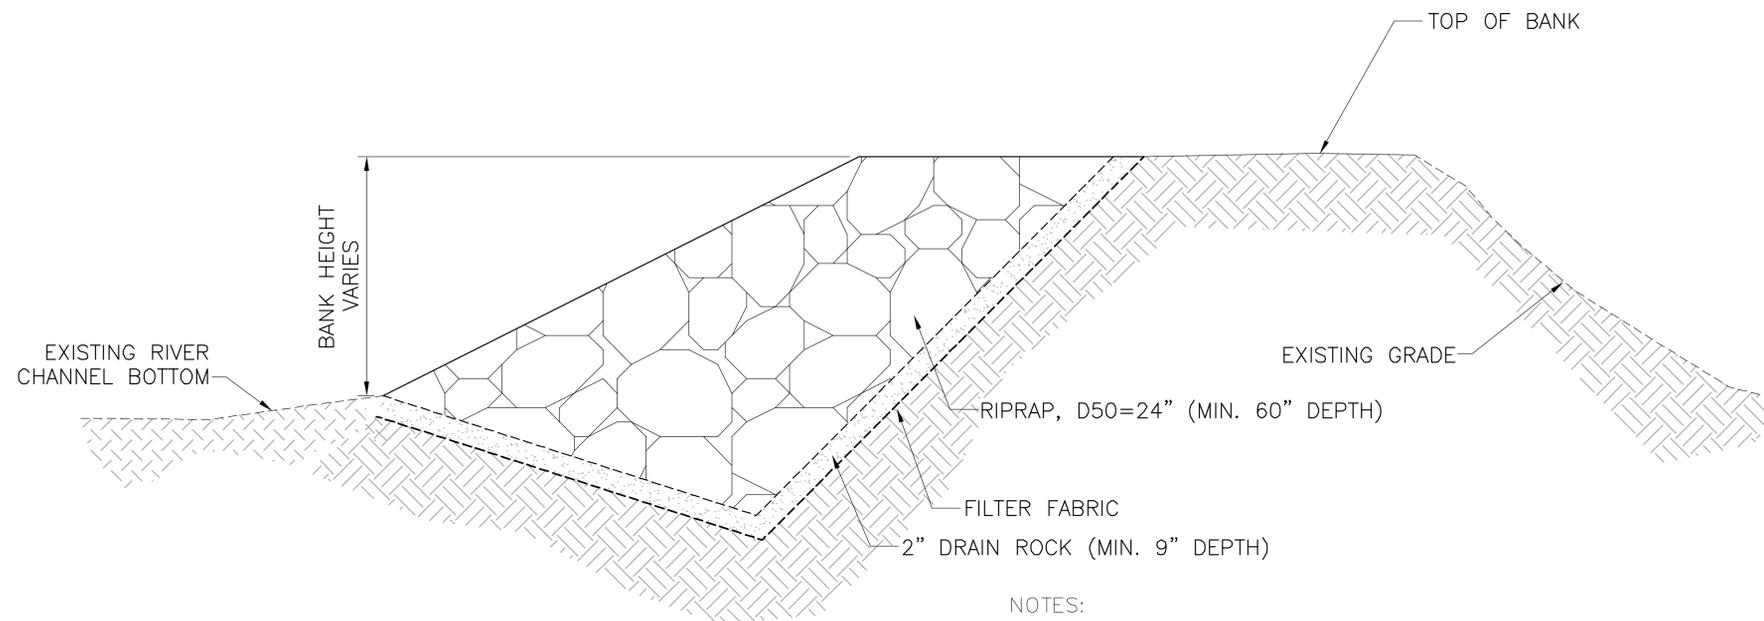
1. RIPRAP SHALL BE A MINIMUM D50=24 INCHES, PLACED ON FILTER FABRIC.
2. RIPRAP STONE SHALL CONSIST OF SUB-ANGULAR FIELD STONE OR ROUGH, UNHEWN QUARRY STONE OF APPROXIMATELY RECTANGULAR SHAPE.
3. STONES SMALLER THAN 12 INCHES SHALL BE MORTARED IN PLACE.
4. RIPRAP SHALL BE PLACED ON THE SIDE SLOPES TO THE TOP OF THE BANKS, UNLESS OTHERWISE INDICATED ON THE PLANS.

Rip-rap channel armoring is recommended for this area. A maximum velocity of 11.7 fps, determined by HEC-RAS, and a unit weight of 135 pounds per cubic foot (pcf), was used to size the rip-rap armoring. The Ishbash method of stream bank rip-rap design was used to determine the required rip-rap size. The computer program Riprap 2.0 was used to verify the required rip-rap sizing. A D_{50} of 2.0 to 2.5 feet is recommended. See Appendix C for rip-rap calculations.
